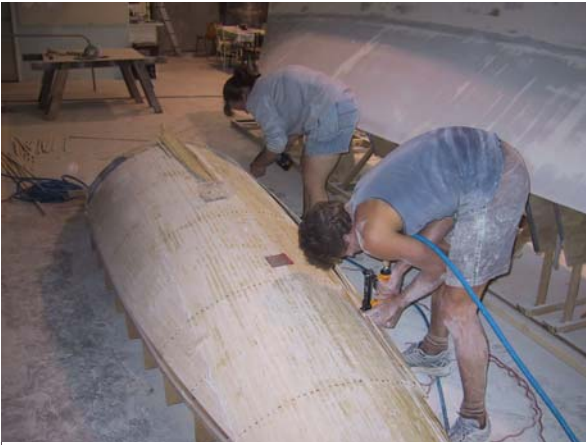
Cabin mold stripped up using durakore strips

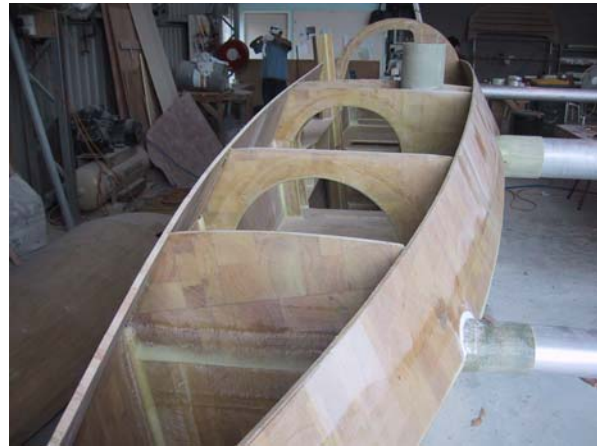
Bulkheads, side panels and tube sockets

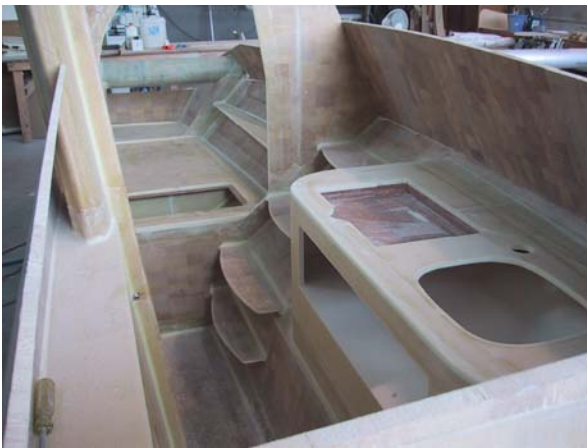
Galley—looking aft into berth. Daggerboard case—see left.

The accommodation is working out really well, some of us shorter people have standing headroom in the galley and the aft bunk looks big enough for a double if you're friendly. Furniture is foam Duflex.

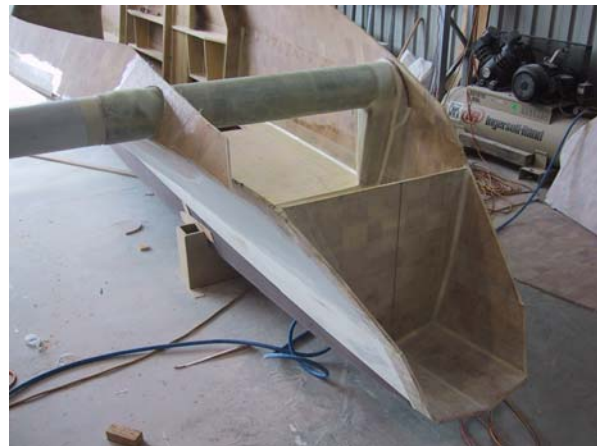
Aft beam socket.

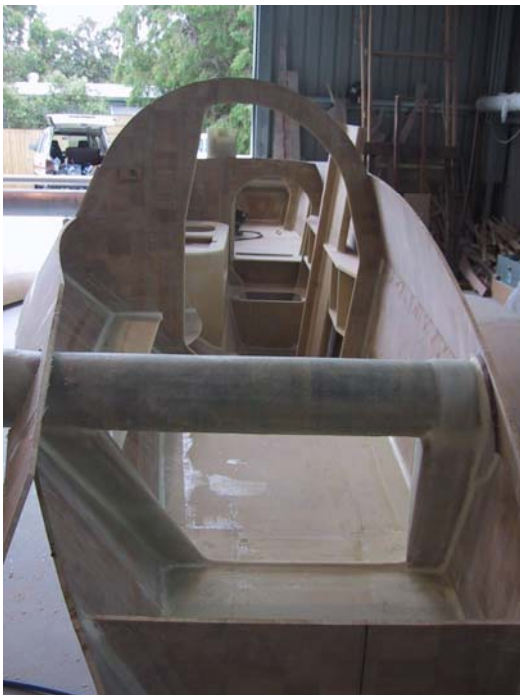
Starboard hull looking from aft fwd.

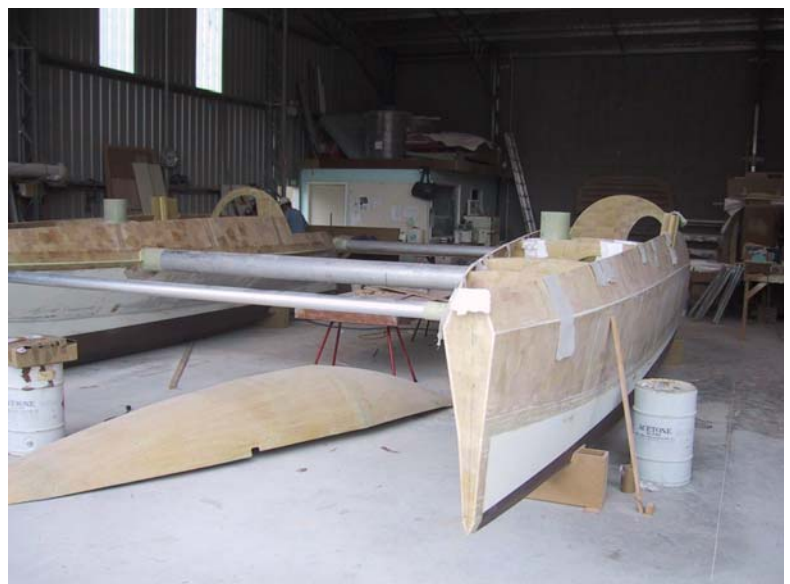
Note mast sockets in each hull. Cabin lying on floor.
